**SITE ANALYSIS - DOWNTOWN ALLISTON**

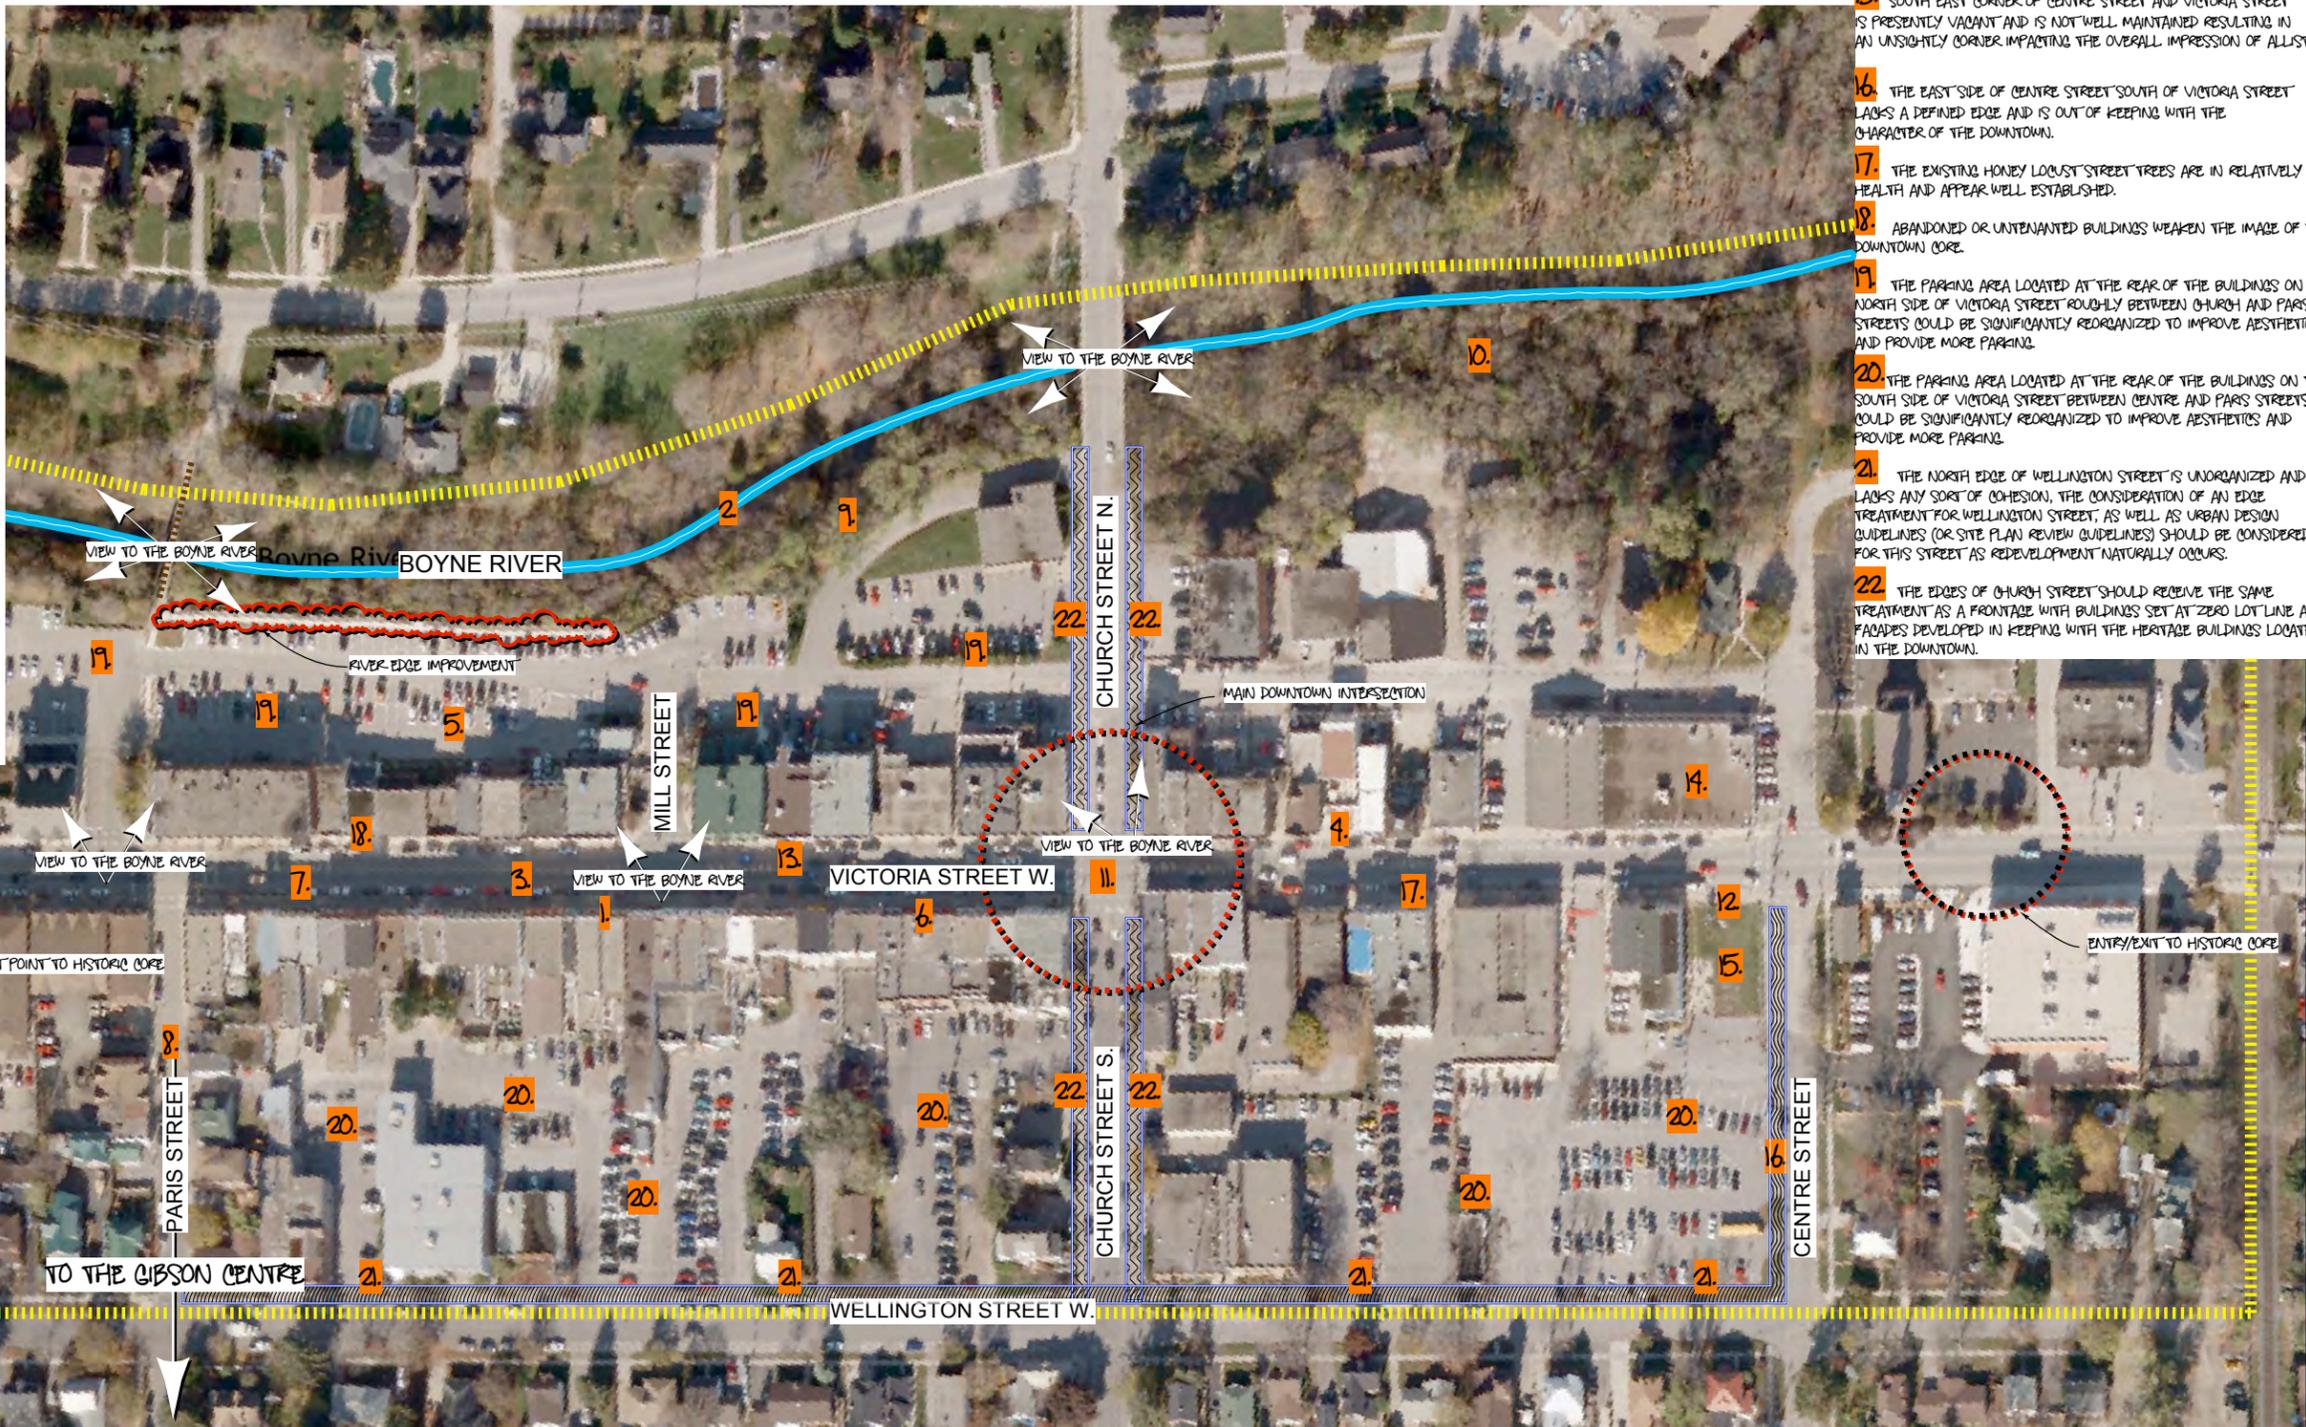
- 1. SOME BUILDING FACADES HAVE BEEN ALTERED INCONSISTENT WITH HISTORIC DETAILING.
- 2. THE PROXIMITY OF THE BOYNE RIVER IS NOT ALWAYS APPARENT WHEN VISITING DOWNTOWN ALLISTON.

- 3. THE STREET APPEARS OVERLY WIDE WHICH IMPACTS THE PERCEPTION OF THE PEDESTRIAN REALM AND EMPHASIZES THE AUTO REALM.
- 4. BUILDING HEIGHT IS GENERALLY LACKING. THE EXISTING ONE AND TWO STORY BUILDINGS DO NOT ADEQUATELY ENCLOSE THE STREET, WHICH IMPACTS ON THE PERCEPTION OF THE ROAD WIDTH, MAKING THE BUILDINGS FEEL OUT OF SCALE WITH THE STREET.

- 5. THE LARGE REAR PARKING LOTS NEXT TO THE BOYNE RIVER ON THE NORTH SIDE OF VICTORIA STREET FACE MOSTLY UNATTRACTIVE REAR FACADES.
- 6. THE ENTRY/EXIT POINTS TO THE DOWNTOWN CORE ARE NOT IDENTIFIED.

- 7. VICTORIA STREET IS ALSO PROVINCIAL HIGHWAY 89 AND IT CARRIES A LARGE VOLUME OF TRANSPORT TRUCK TRAFFIC WHICH NEGATIVELY IMPACTS THE PEDESTRIAN NATURE OF THE DOWNTOWN.

- 8. THE GIBSON CENTRE (A VALUABLE AND ATTRACTIVE LOCAL ASSET) IS POSITIONED RELATIVELY CLOSELY TO DOWNTOWN CORE.
- 9. THE TREATMENT OF THE SOUTHERN EDGE OF THE BOYNE RIVER DOES NOT INTEGRATE THE RIVER WELL INTO THE TOWN.

- 10. THE TOWN DOES NOT APPEAR TO CELEBRATE THE PRESENCE OF THE BOYNE RIVER BECAUSE IT IS LARGELY HIDDEN FROM VIEW AND THE EDGE BEING A PARKING LOT IMPLIES A LACK OF INTEREST IN THIS HERITAGE FEATURE (THE ONE PEDESTRIAN BRIDGE AND THE EDGE TREATMENT LOCATED AT THE WESTERN END OF THE STUDY AREA DOES HELP MITIGATE THIS SOMEWHAT).

- 11. THE MAIN INTERSECTION OF THE STUDY AREA (VICTORIA AND CHURCH) DOES NOT DEMONSTRATE A GREAT DEAL OF CHARACTER WEAKENING THE OVERALL IMAGE OF THE DOWNTOWN.

- 12. BREAKS IN THE STREET WALL (BUILDING FACE) BREAK UP THE CONTINUITY OF THE DOWNTOWN.

- 13. THE COACH-STYLE STREET LAMPS, STREET TREES, HANGING FLOWER BASKETS, BENCHES, BRICKED BUMP OUTS, AND THE "DOWNTOWN ALLISTON CLOCK" INDICATE THAT THE DOWNTOWN IS MAINTAINED AND INVESTED IN, THESE ELEMENTS ADD TO THE OVERALL CHARACTER OF THE TOWN.

- 14. THE BUILDING MASS LOCATED AT THE NORTH WEST CORNER OF CENTRE AND VICTORIA STREET IS INCOMPATIBLE WITH THE DOWNTOWN CORE.
- 15. SOUTH EAST CORNER OF CENTRE STREET AND VICTORIA STREET IS PRESENTLY VACANT AND IS NOT WELL MAINTAINED RESULTING IN AN UNSIGHTLY CORNER IMPACTING THE OVERALL IMPRESSION OF ALLISTON.

- 16. THE EAST SIDE OF CENTRE STREET SOUTH OF VICTORIA STREET LACKS A DEFINED EDGE AND IS OUT OF KEEPING WITH THE CHARACTER OF THE DOWNTOWN.
- 17. THE EXISTING HONEY LOCUST STREET TREES ARE IN RELATIVELY GOOD HEALTH AND APPEAR WELL ESTABLISHED.

- 18. ABANDONED OR UNMAINTAINED BUILDINGS WEAKEN THE IMAGE OF THE DOWNTOWN CORE.
- 19. THE PARKING AREA LOCATED AT THE REAR OF THE BUILDINGS ON THE NORTH SIDE OF VICTORIA STREET ROUGHLY BETWEEN CHURCH AND PARIS STREETS COULD BE SIGNIFICANTLY REORGANIZED TO IMPROVE AESTHETICS AND PROVIDE MORE PARKING.

- 20. THE PARKING AREA LOCATED AT THE REAR OF THE BUILDINGS ON THE SOUTH SIDE OF VICTORIA STREET BETWEEN CENTRE AND PARIS STREETS COULD BE SIGNIFICANTLY REORGANIZED TO IMPROVE AESTHETICS AND PROVIDE MORE PARKING.

- 21. THE NORTH EDGE OF WELLINGTON STREET IS UNORGANIZED AND LACKS ANY SORT OF COHESION, THE CONSIDERATION OF AN EDGE TREATMENT FOR WELLINGTON STREET, AS WELL AS URBAN DESIGN GUIDELINES (OR SITE PLAN REVIEW GUIDELINES) SHOULD BE CONSIDERED FOR THIS STREET AS REDEVELOPMENT NATURALLY OCCURS.

- 22. THE EDGES OF CHURCH STREET SHOULD RECEIVE THE SAME TREATMENT AS A FRONTAGE WITH BUILDINGS SET AT ZERO LOT LINE AND FACADES DEVELOPED IN KEEPING WITH THE HERITAGE BUILDINGS LOCATED IN THE DOWNTOWN.
